RESIDUE DISPOSAL AT SADIOLA HILL GOLD MINE: STABILITY EVALUATION BY FIELD TESTING

by A Mac G Robertson *, T Lloyd, M Robins*****

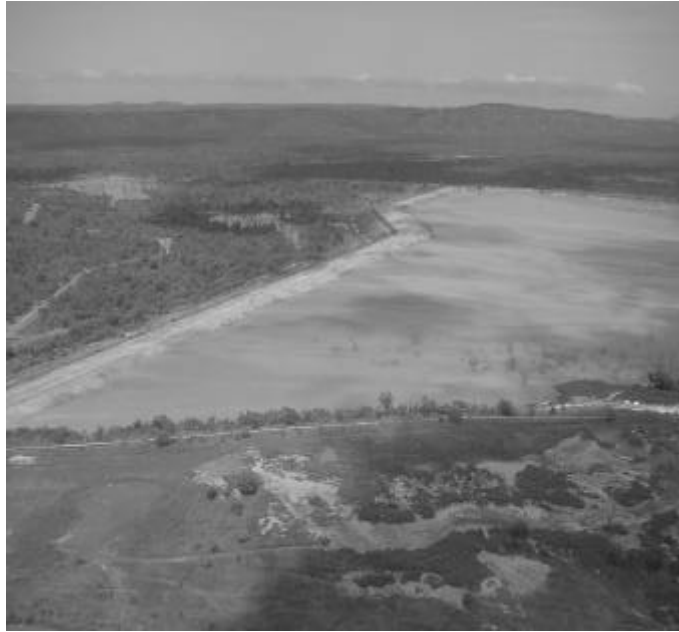
Figure 2: Photograph of Sadiola residue deposit from the air (September 2001)

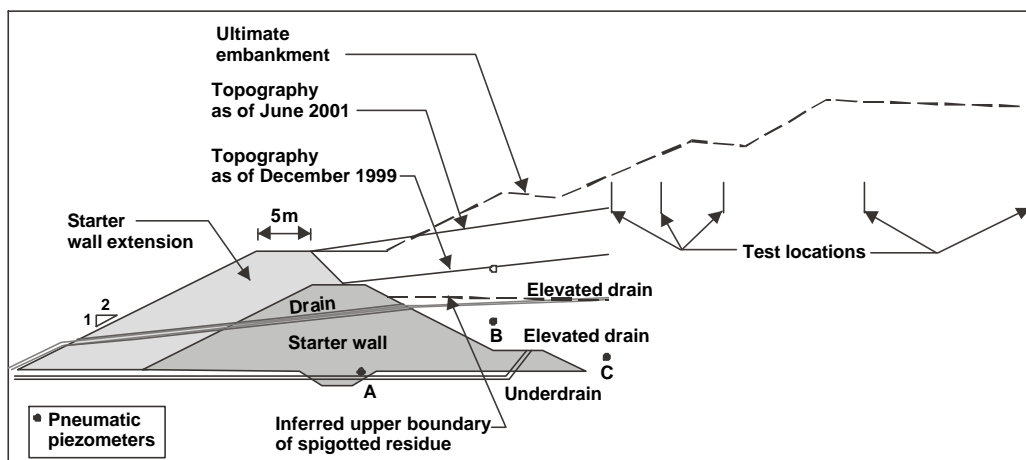
Based on the results of the laboratory and field testing the embankment section shown in Figure 3 was designed, and implementation of cycloned residue upstream raising commenced in 1998. The construction method involves the upstream raising of the embankment using a large number of small cyclones at relatively close spacing. The cyclone coarse residue raised embankment in September 2001 is shown in Figure 4. The low volume of underflow (~15% by weight) produces a relatively narrow coarse beach residue as is evident in Figure 5. The initial cycloned raise is constructed on the initial deposit of spigotted feed (see Figure 3) and the subsequent raisings progressively advance over the overflow within the interior of the impoundment.

Figure 3: Typical cross-section

- Piezocone testing at 20 positions on five sections such as that illustrated in Figure 3.
- Shear vane testing at 1 m intervals at 16 positions on the same five sections.
- Auger sampling at 1 m intervals to a depth of 6m to determine in-situ void ratios and index properties
- Sampling of feed, underflow and overflow for settlement and consolidation, shear strength, permeability, grading and index testing.

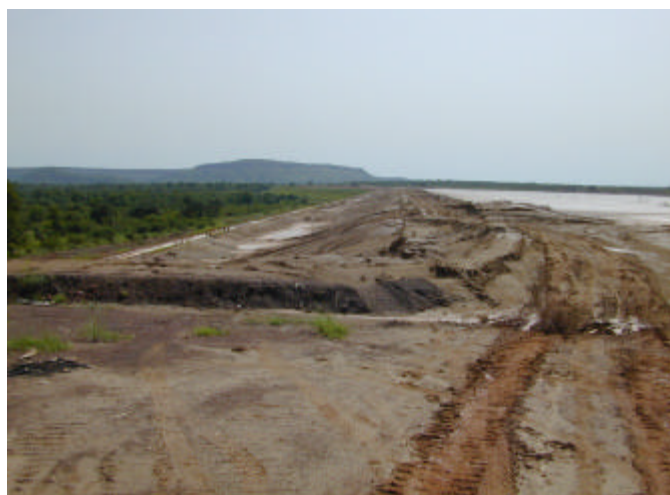
Figure 4: Sadiola deposit showing cycloned upstream raising (Sept. 2001)

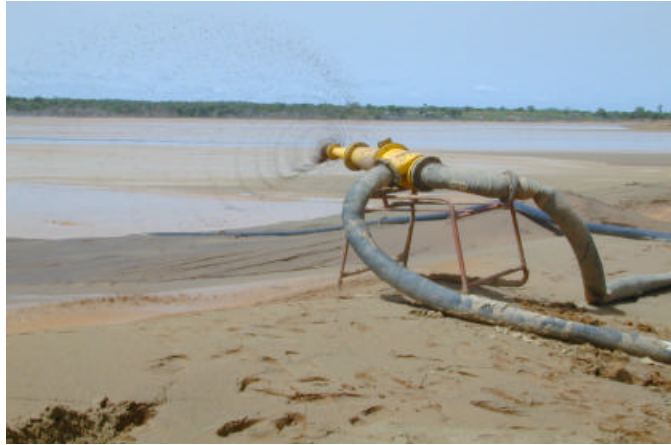
Figure 5: Sadiola deposit showing narrow sand beach – note overflow discharge location to ‘pond’ at end of short beach

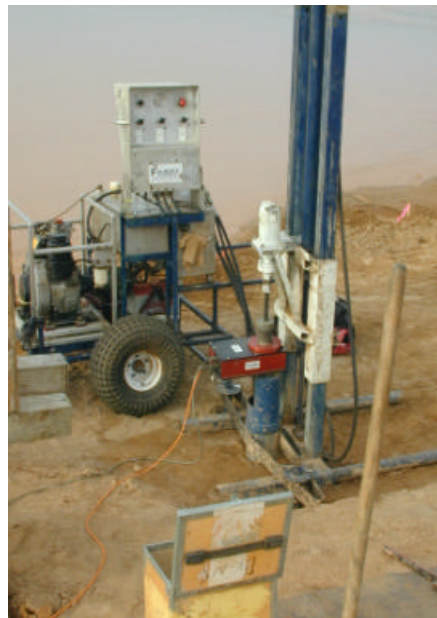
Figure 6: Pushing frame used for shear vane testing – also for piezocone probing

The apparatus for shear vane testing is shown in Figure 6. The same pushing frame was also used for piezocone testing.

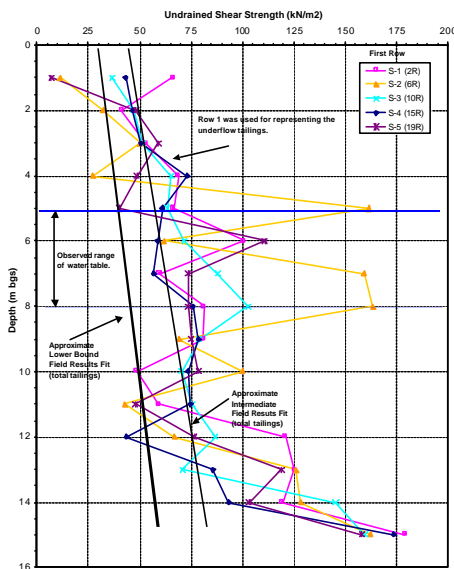
Figure 7: Field Test Data and Shear Strength Profile - First Row

The shear vane strength profiles determined for the row of shear vane tests performed closest to, and furthest from the starter wall crest are shown in figures 7 and 8. A large reduction of shear strength is apparent, indicating that drainage, consolidation and shear strength conditions are less favourable with increasing distance from the starter wall crest. Continued upstream raising will advance the embankment over increasing weak material. The low strength total residue from initial deposition is observed between 10 and 12 m depth in row 1 (Figure 7). Below this there is an increase in shear strength due to drainage to the pervious foundation soils and starter wall drain. High strength coarse layers are observed in this row. The results for Row 4 indicate that more uniformly low shear strengths exist at this distance from the starter wall. The two dark lines on each of the figures indicate the approximate lower bound and typical strengths interpolated from all the probe results.

Vane shear strengths measured in the outermost location of each of the five sections investigated (dotted line marked 'Approximate Intermediate Field Results Fit') were deemed representative of the overflow strengths. Comparison of these two estimates of shear strength is remarkably good. A similar examination of vane shear strengths and pore pressures in the feed residue suggests that the consolidated undrained shear strengths of the residue can be reasonably represented by the same expression as for the overflow. The in-situ vane shear tests showed that the coarser underflow is stronger than the finer overflow and the strength was evaluated to be represented by the expression $S_u = 30 + 0.3p$ (kPa).

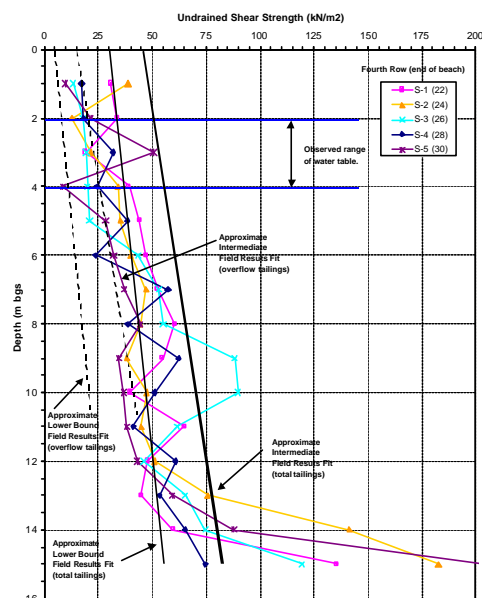
Figure 8: Field Test Data and Shear Strength Profile - Fourth Row
